## FACILITY COMPLIANCE INSPECTION REPORT

Moldenhauer LCID Landfill 1957 Lystra Road Chapel Hill, NC 27517

Comprehensive Audit (to ensure that the notified Land Clearing and Inert Debris (LCID) landfill is in compliance with 15A North Carolina Administrative Code (NCAC) 13B .0563, .0564, and .0566)

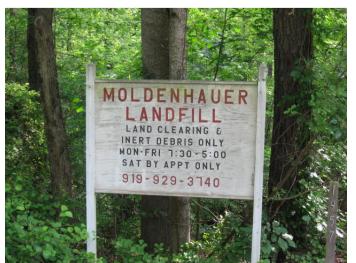
Facility signage

- 10. Soil is stored on the lot.
- 11. Access roads are of all-weather construction.
- 12. The site is properly secured.
- 13. The facility has proper signage although it will be updated to reflect the T&PN operation.

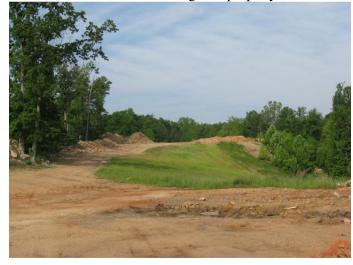
LCID landfill – view to the right of property

- 9. Inert debris and logs for firewood are stored atop the LCID landfill cap. Material is stored on the left side of the lot, for business use, and the T&PN operation is located on the right site.
